# Runnins River Watershed Stormwater Management Study

December 1994

**US Army Corps  
of Engineers**  
New England Division

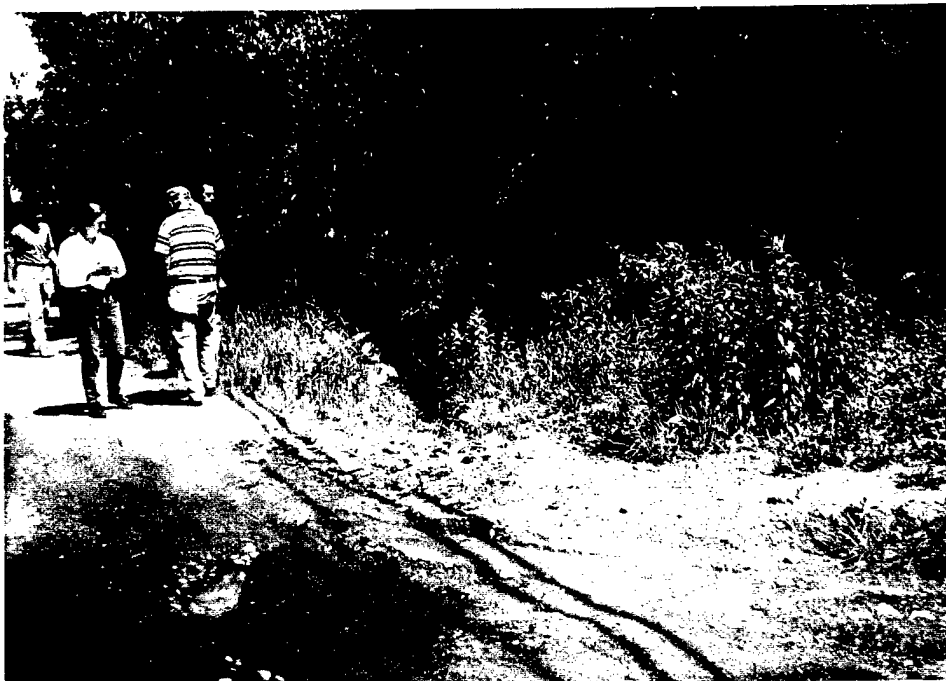
**Photo 3: Erosion problems at intersection of Arcade Avenue and Ledge Street, Seekonk. Area drains to Runnins River tributary.**

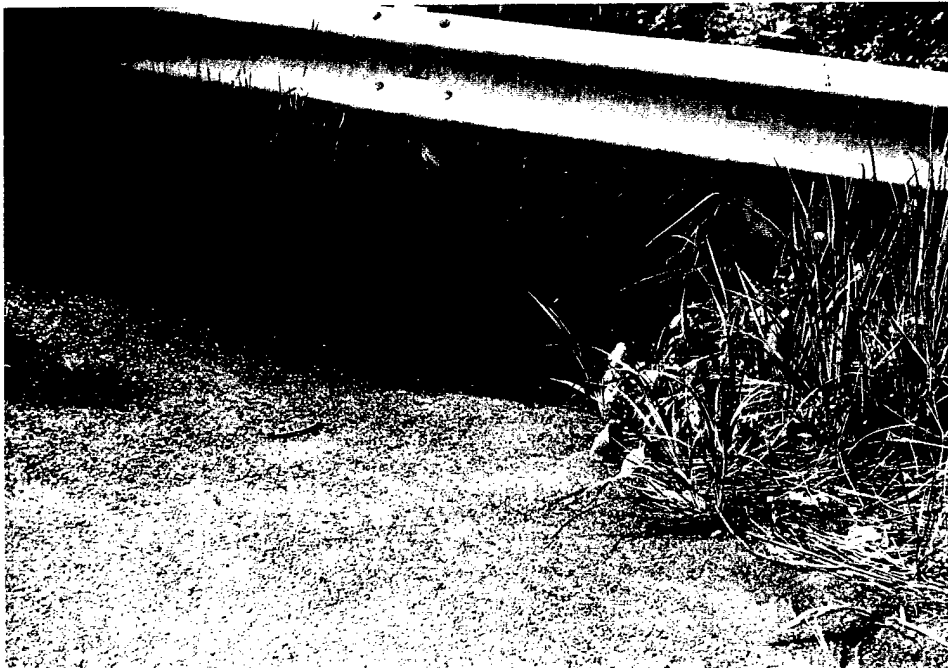
**Photo 8: Paved Drainage Swale, School Street  
(stateline)**
